SAFETY  
SHARE!

## Drill Rig OPL Strike

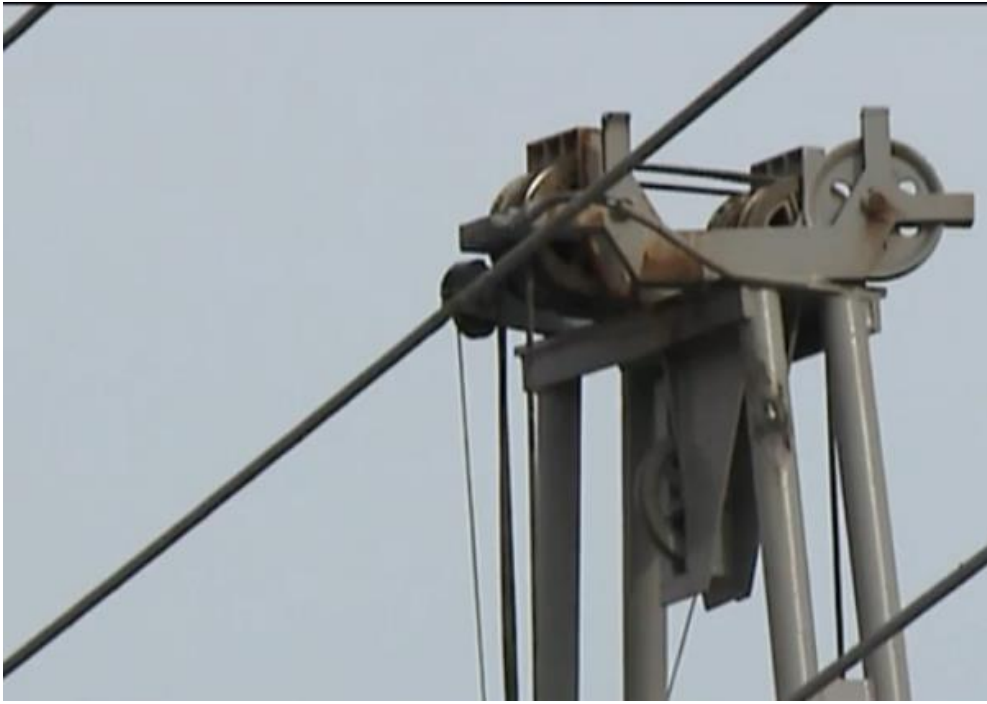
A boom truck hit a power line at around 10 a.m. near Interstate 44 east of Mraz Road. One person has died as a result of the accident -- a contract worker for MoDOT.

When Tepatti raised the boom to drill for a sample, he hit a high-power line and was electrocuted by 12,000 volts.

The electricity from the line caught the back tires of the truck on fire.

“The force of that actually blew a hole in the concrete, so it’s a tremendous amount of current

that was passing down through there,” Thompson said.

The incident caused the ground wire, which stretches across I-44, to snap. That ground wire plays an important role in distributing electricity to Ameren customers. Traffic was backed up the area as traffic was shut down in both directions while Ameren crews put up a new ground line.

This is not the first company, not the first driller – but can be the last if we follow this one simple rule: **“Look Up & Live”!** This includes being mindful of air knife operations being performed ahead of a drill rig showing up that holes are NEVER cleared under/near power lines.

- The MINIMUM is 10 feet from any overhead power line – the distance increases above 50,000 volts by .4” every 1000 volts above 50kV.
